# REPAIRING

## a dial pillar

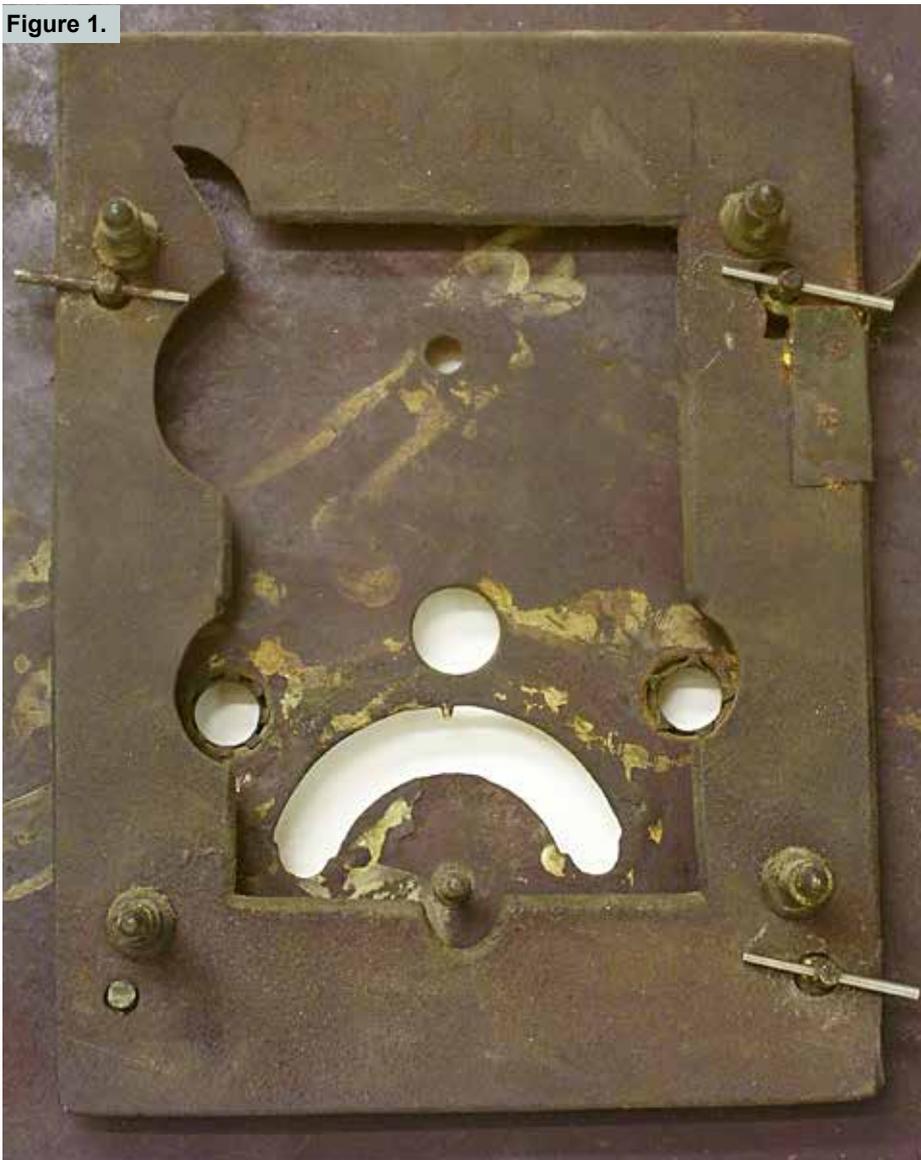
Figure 1.

The dial shown in **figure 1** is a typical longcase moon roller dial from the 1820s. You can see the Osborne falseplate attached to the back of the dial and the absence of a taper pin in the lower left-hand dial pillar.

You can see in **figure 1** that the pins used to attach the falseplate to the dial are quite substantial and if too much force is used when inserting the pins they can easily damage the spigots. In order to repair the dial pillar a new spigot would have to be made and fitted to the dial pillar.

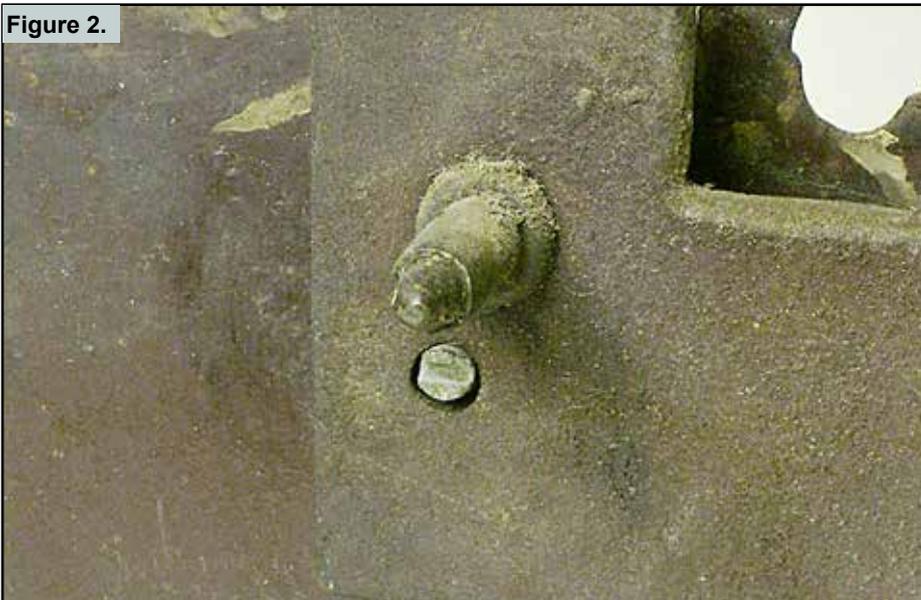
Figure 2.

The close-up in **figure 2** reveals the reason. The hole in the spigot of the dial pillar has burst at some time in the past and it is now no longer possible to attach the dial to the falseplate efficiently. Although the other pillars are undamaged, all four pillars should attach these heavy dials if they are to be positively located to the movement. Not only does this retain the dial in place correctly and prevent movement, but also evens out the stresses on the dial preventing further damage.

I decided to machine a threaded spigot to match the existing hole in the falseplate and drill and tap the dial pillar. The spigot hole in the falseplate was just under

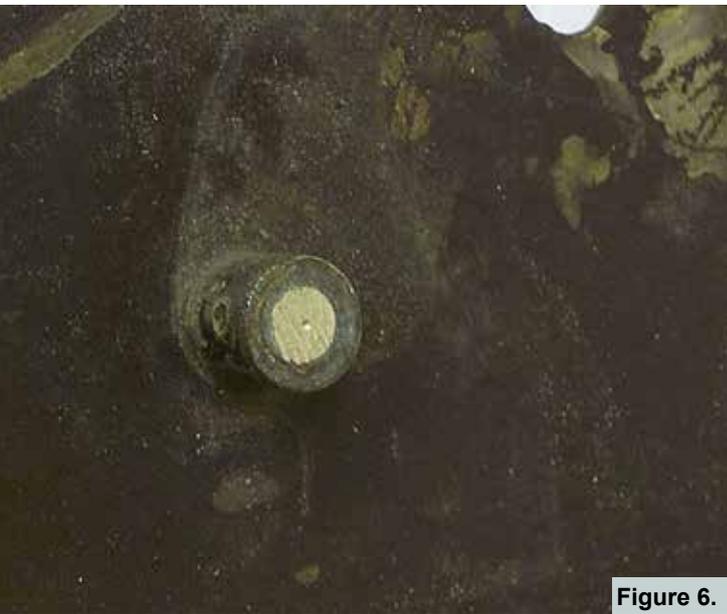
Figure 9.

Readers will notice that I have deliberately fitted a smaller taper pin to the repaired dial pillar. In my opinion the other pins are far too large for the diameter of the spigots and this may well have been a contributing factor to the damage caused to the repaired pillar. ●

When happy with the fitting of the spigot and taper pin the spigot was unscrewed and a couple of drops of Loctite applied to the threads before tightly screwing the spigot into the dial pillar. The pinned-up false plate is shown in **figure 9**.
